Vehicle History Report

Chassis number ¹: RU

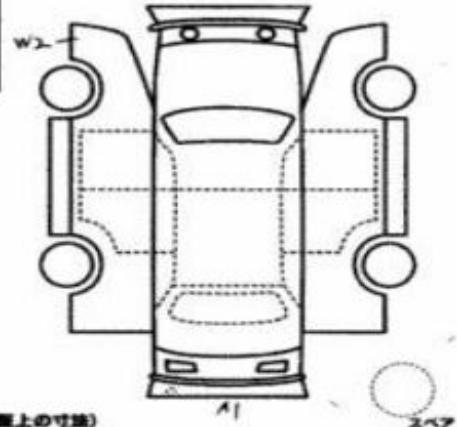
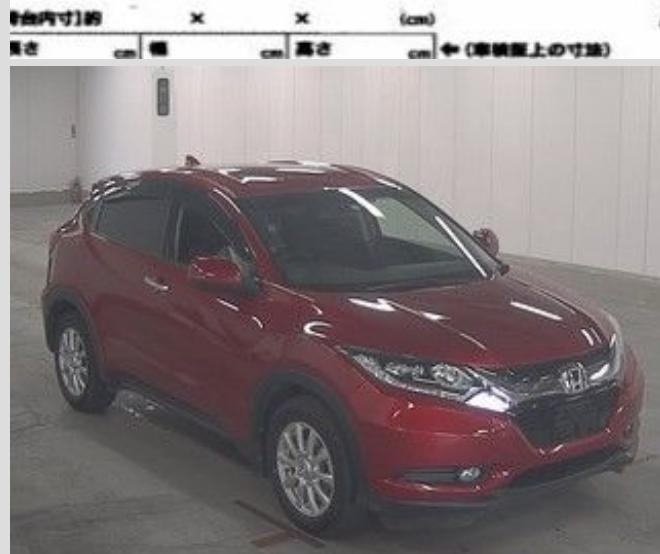
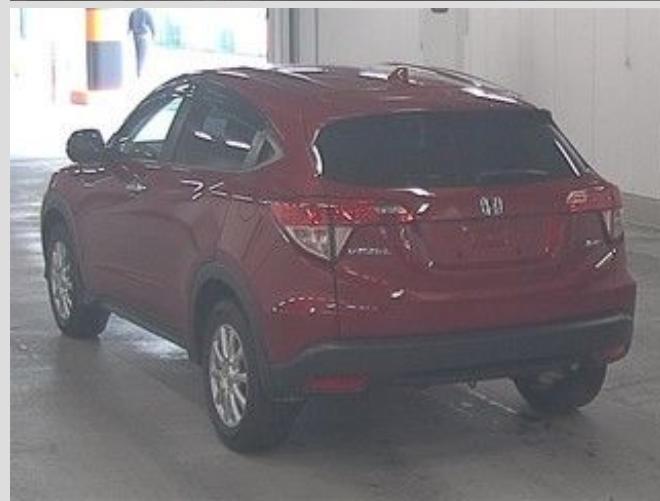
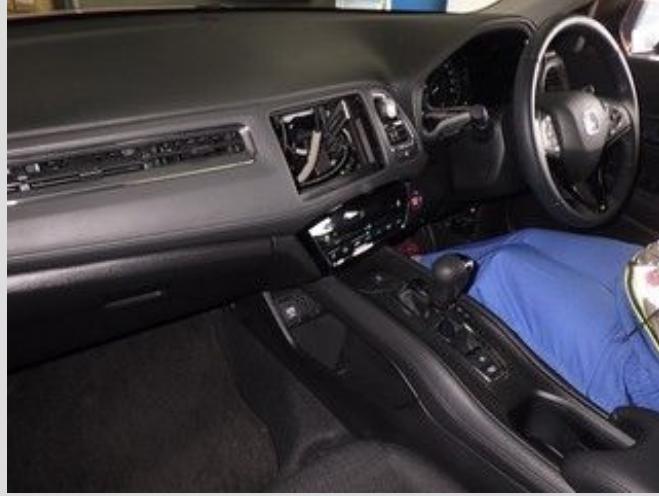
R／1コーナー

車番 1566	車種 (自動車外は記入) ホンダ	排気量 1500	型式 DBA-RV2	評価点 R
初登録年月 29/1月	車名 ヴェゼル	走行距離 7561 Km	グレード S	2WD
外色 白	内色 カラー無	冷房 AAC	SR	MAW
内色 黒	内装色 RSLSM	暖房 (運転席)	TV	ナビ
運転席 オリジン・運転・()	助手席 ハンドル	電動助手席 (運転席)	エアコン	
運転席 ティーラー・並行 左・右	助手席 ハンドル	運転席と助手席に運転下さい。	シートヒーター左右	
リサイクル料金 12850 円		車両登録	車両登録	
○生産年月 (生産・不適合箇所および状態)		車台番号 RV2-1202529	シリアル番号	
☆ドアバイザー ☆ワイパー ミラー ☆フロント

○検査員報告

ホディオレス
トキス・クオス
ホライル・アドレス
左Fタイヤ 195/65R15
右Fタイヤ 195/65R15
