Vehicle History Report

Chassis number ¹: RU

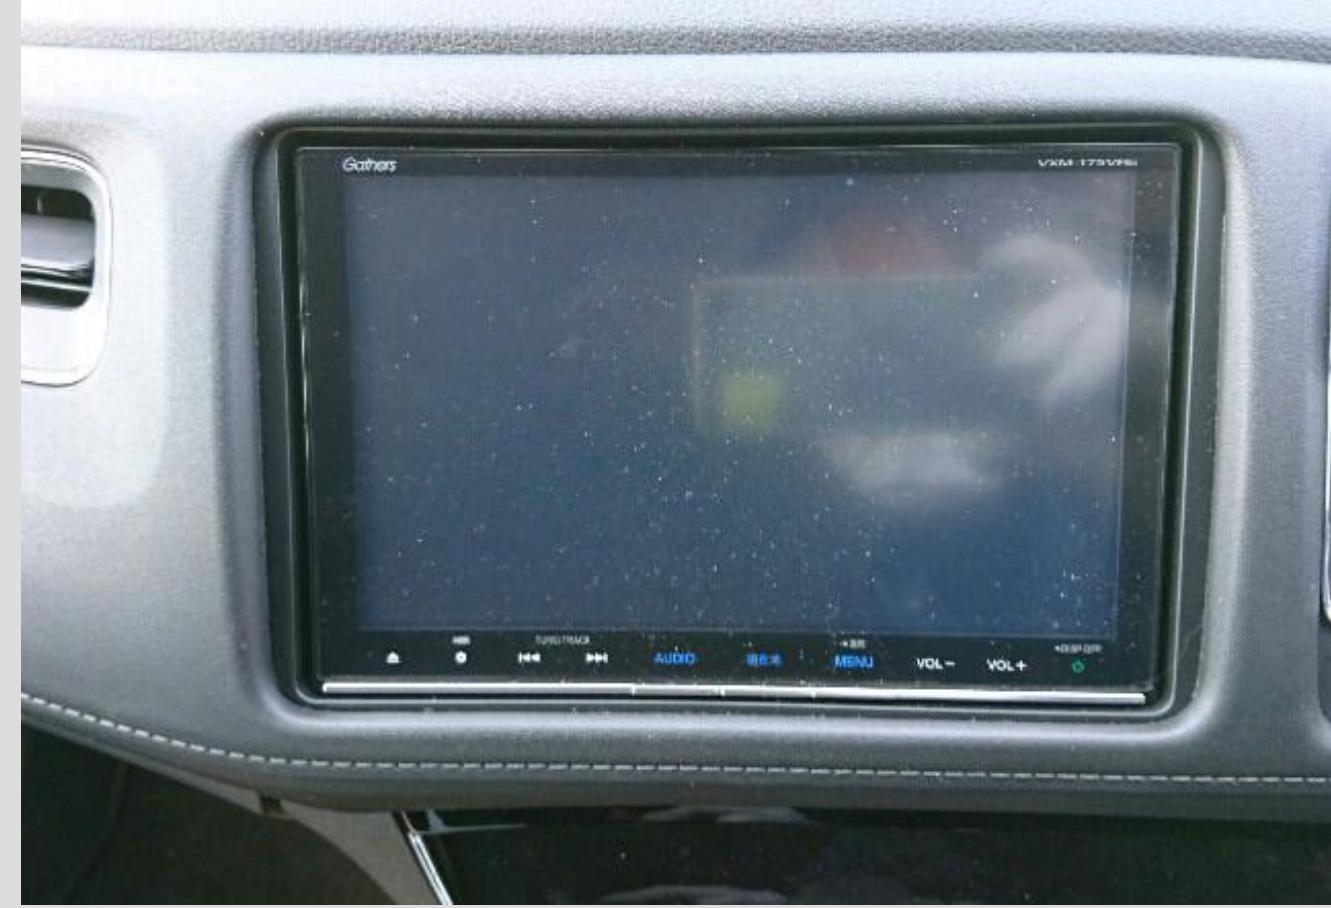
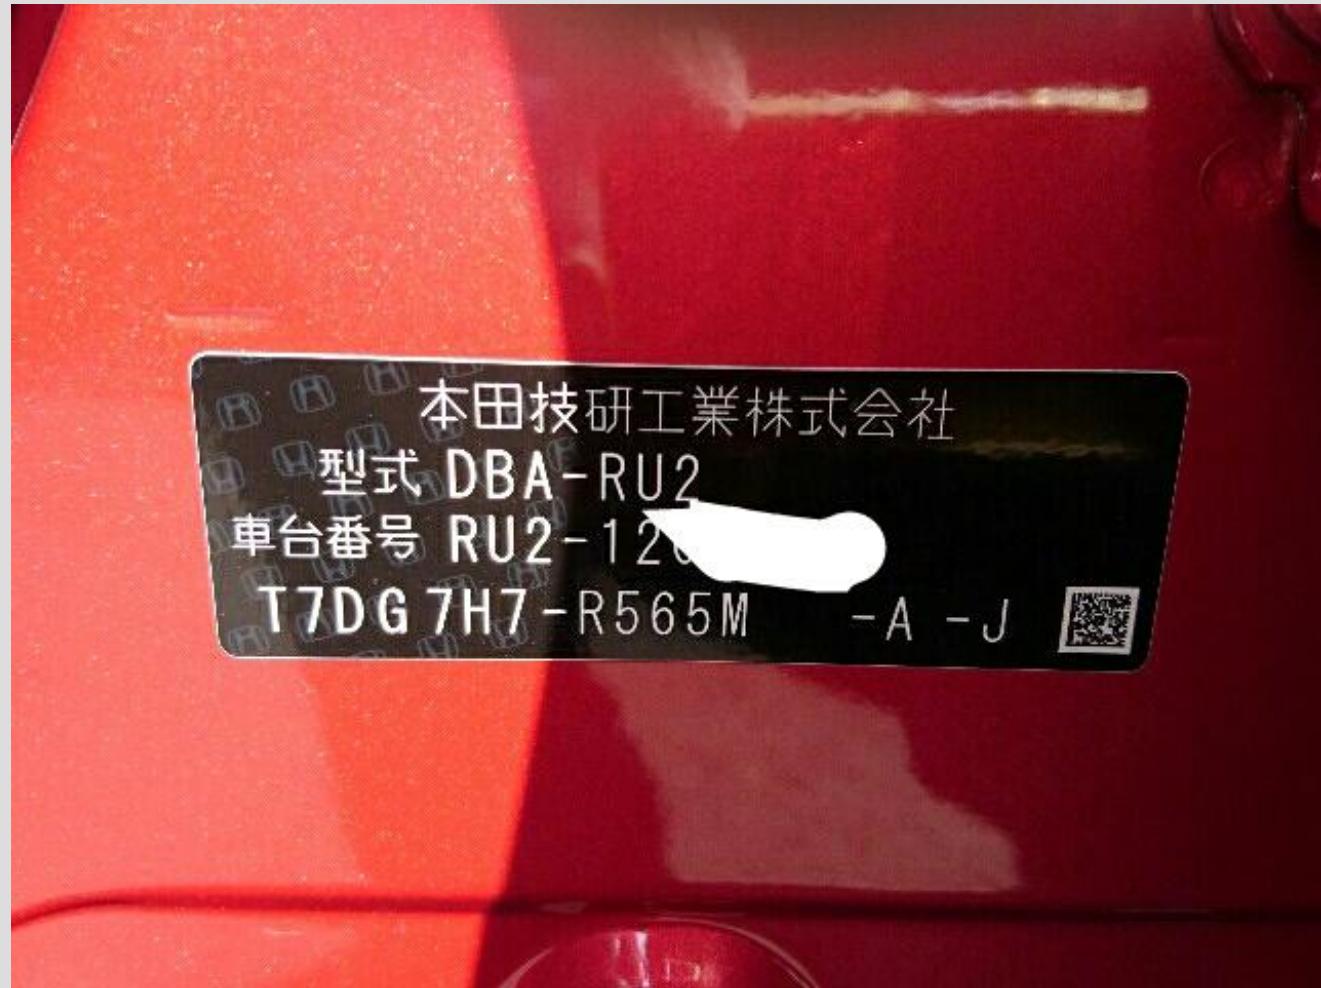
R／1コーナー

車番 1566	車種 (自動車外は記入) ホンダ	排気量 1500	型式 DBA-RV2	評価点 R
初登録年月 29/1月	車名 ヴェゼル	走行距離 7561 Km	グレード S	2WD
外色 白	内色 カラー無	冷房 AAC	SR	MAW
内色 黒	内装色 RSLSM	暖房 (運転席)	TV	ナビ
運転席 オリジン・運転・()	助手席 ハンドル	電動助手席 (運転席)	エアコン	
運転席 ティーラー・並行 左・右	助手席 ハンドル	運転席と助手席に運転下さい。	シートヒーター左右	
リサイクル料金 12850 円		車両登録	車両登録	
○生産年月 (生産・不適合箇所および状態)		車台番号 RV2-1202529	シリアル番号	
☆ドアバイザー ☆ワイパー ミラー ☆フロント
